FACILITY COMPLIANCE INSPECTION REPORT

Division of Waste Management Solid Waste Section

Date of Site Inspection: August 18, 2011 **Date of Last Inspection:** May 5, 2011

River City Transfer Station
 1049 South Eastern Blvd
 Fayetteville, North Carolina 28306

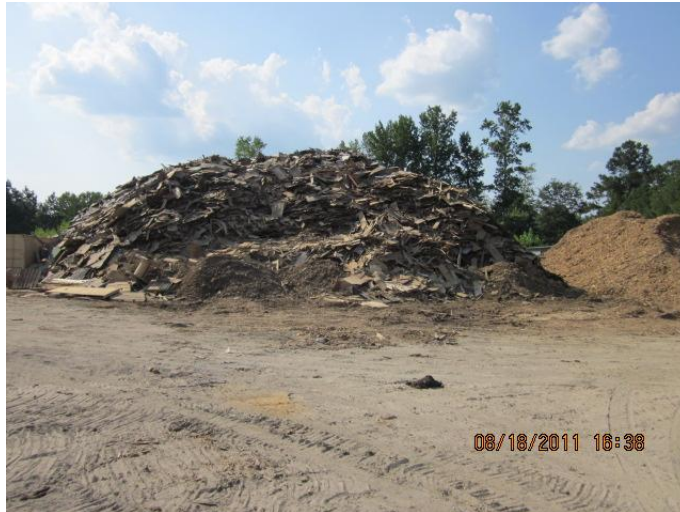
5. The remaining EWW pile was approximately 147' W by 138' L by 25' H and is located along the edge of an existing pond.
6. The "clean lumber" pile had been removed from along the road. Documentation showing the disposal destination for the removed wood must be provided to ensure waste was disposed of properly.

Engineered wood waste pile, grinds on right side.

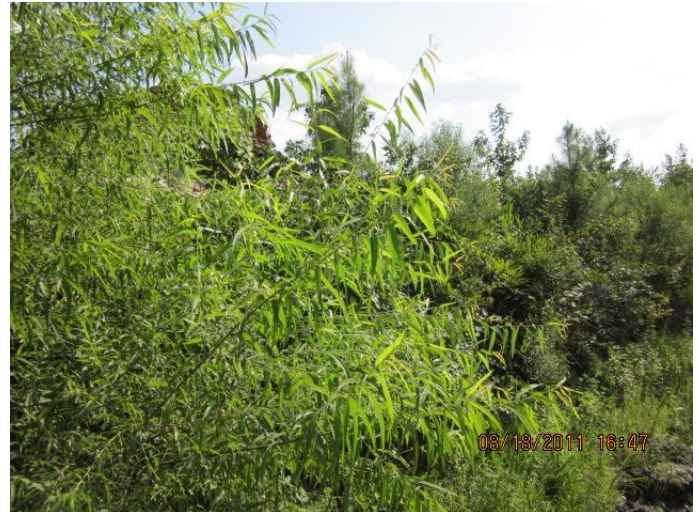
EWW adjacent to onsite pond.

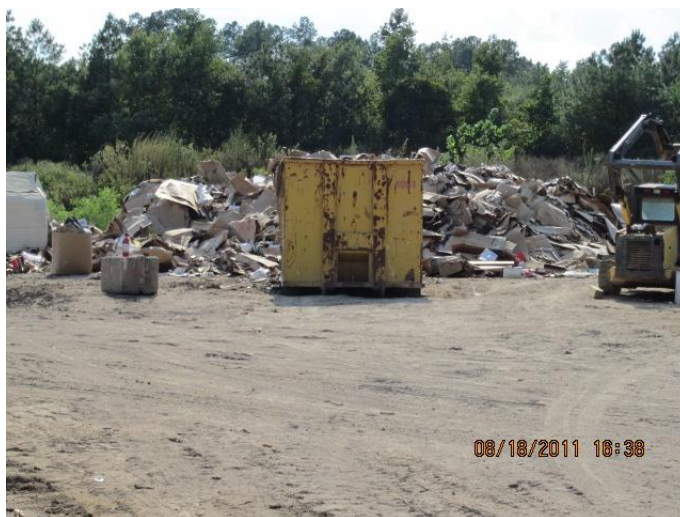
2. Permit to operate part 16 states that "Except for wood, concrete and aggregate, recyclable materials must be placed in containers by the end of the working day." You are in violation of this part of the permit in that separated EWW, cardboard and scrap metal were observed on the ground outside boundaries of the WTS and not in a container.

Cardboard and misc waste on ground beyond the TS boundary marker.

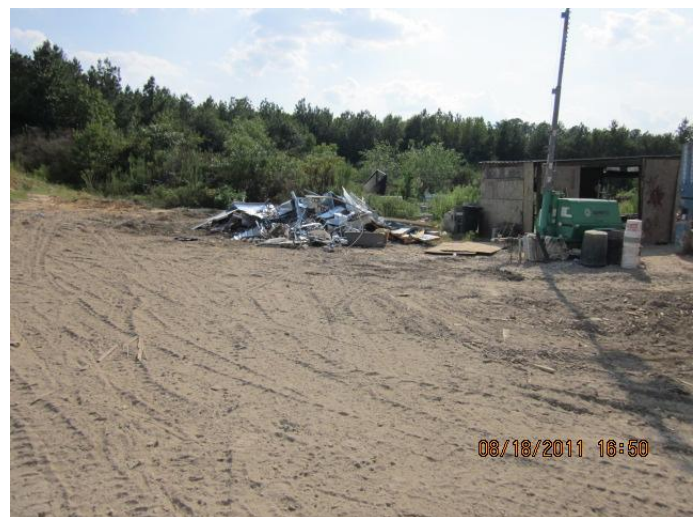
Scrap metal dumped on the ground.
